Equivalent Crack Size Modelling of Corrosion Pitting in an AA7050-T7451 Aluminium Alloy and its Implications for Aircraft Structural Integrity

Bruce R. Crawford and P. Khan Sharp

DSTO-TR-2745

ECS Modelling of 7050 Aluminium Alloy Corrosion Pitting and its Implications for Aircraft Structural Integrity

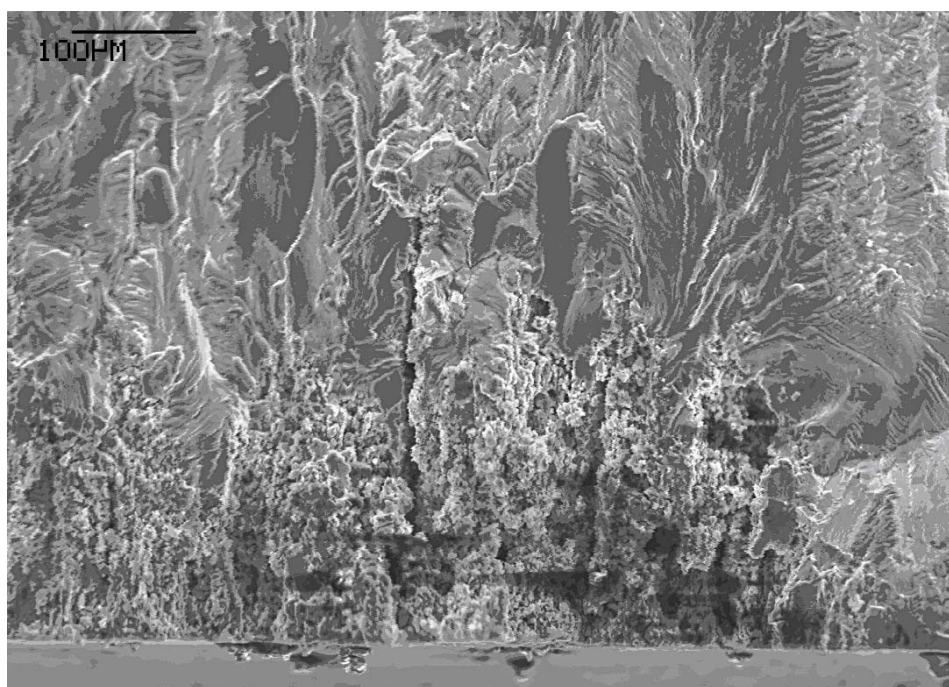
Figure 15: SEM micrographs of a selection of corrosion pits observed on the fracture surfaces of the corroded fatigue specimens. Part (a) shows Specimen KK1H169 which was tested at $\sigma_{max} = 103$ MPa and which failed at 51,240 cycles while (b) shows Specimen KK1H207 which failed after 60,060 cycles at the same stress.

Figure 15 (cont'd): SEM micrographs of a selection of corrosion pits observed on the fracture surfaces of the corroded fatigue specimens. Part (c) shows Specimen KK1H293 which was tested at a σ_{max} of 69 MPa and which failed at 318,114 cycles while (d) shows Specimen KK1H296 which failed after 16,319 cycles at 138 MPa.

Figure 15 (cont'd): A selection of corrosion pits observed on the fracture surfaces of the corroded specimens. Part (e) shows Specimen KK1H427 which was tested at $\sigma_{max} = 69$ MPa and which failed at 189,425 cycles while (f) shows Specimen KK1H435 which failed after 17,737 cycles at $\sigma_{max} = 138$ MPa.
